BLACK LAKE INVASIVE SPECIES INVENTORY REPORT

Created for the Black Lake Association by Huron Pines on November 28, 2017

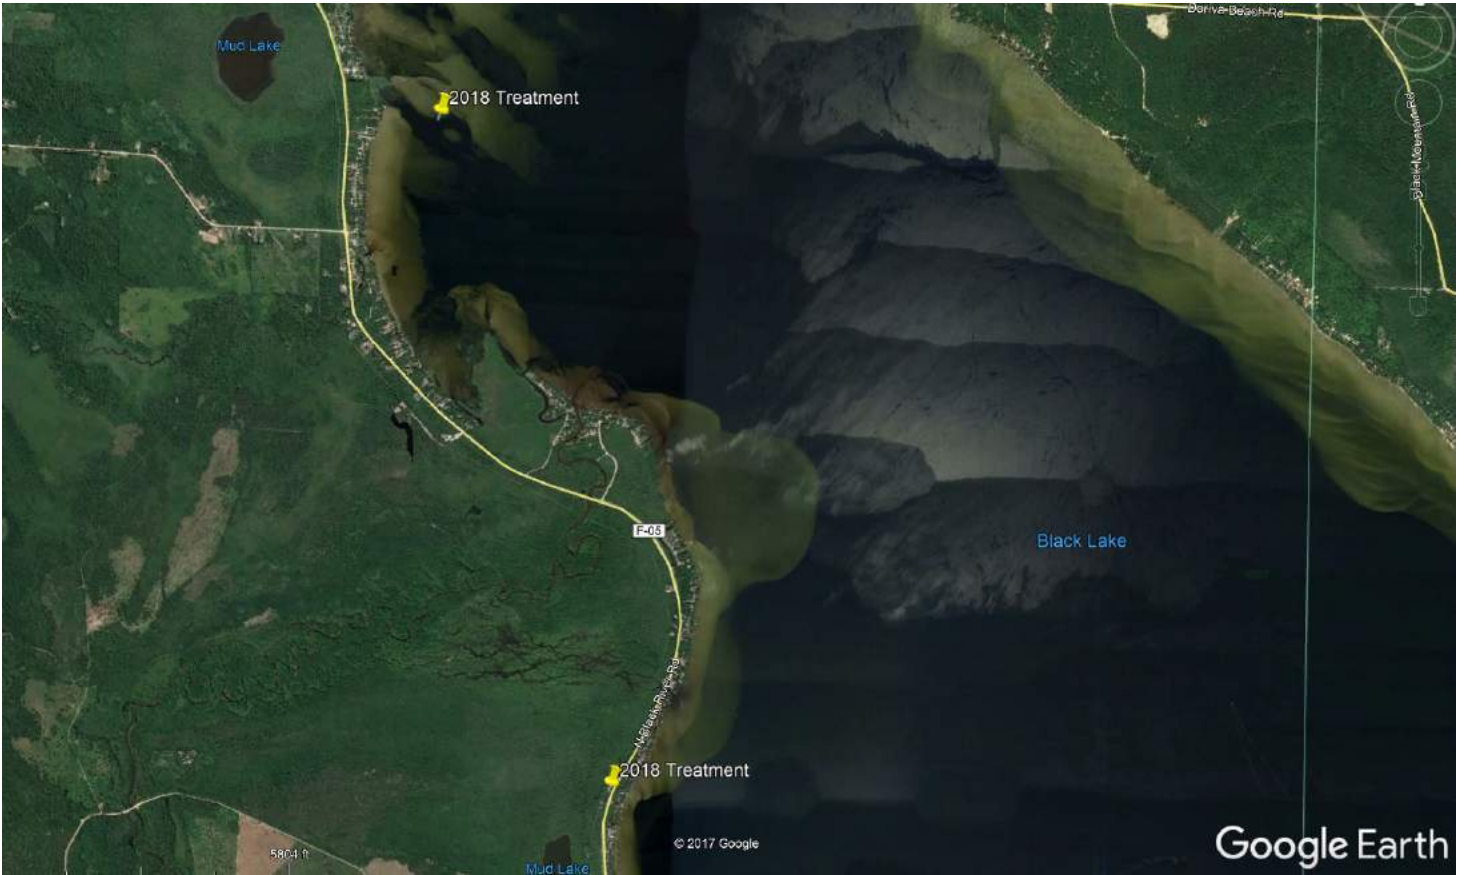
2018 Planned Treatment Sites

Treatment for the site inland along Black River Road and the site along the northwest shore of the lake is scheduled for 2018. (see map below)

The first recommendation for invasive species control on Black Lake would be to deal with the invasive phragmites. Since the invasive phragmites is found growing in the water, a permit from the Department of Environmental Quality is required for chemical treatment. Additionally, permission will be required by the landowner prior to treatment, on both public or private land. It is important, however, that the native phragmites in the area be identified and not treated. The north side of the lake, where both native and invasive species are found, should be monitored each year and when an invasive patch is found it should be treated promptly to reduce the spread of this aggressive plant. ****The estimated cost for treatment of invasive phragmites on Black Lake for 2018 would be \$500. Removal success is dependent on subsequent annual treatment until eradicated, with each year's cost decreasing as the size of the outbreak decreases. Huron Pines is working to identify landowners for inland sites and will work to treat those as well in order to prevent recolonization.***

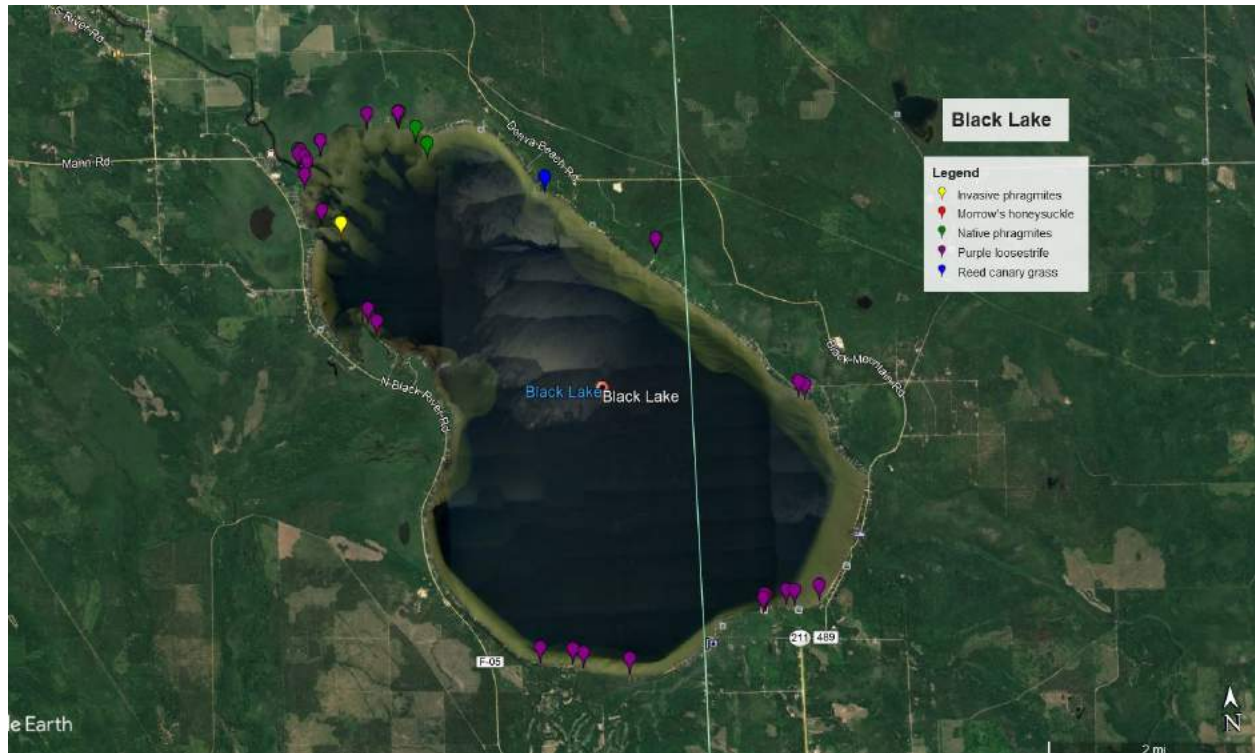
Figure 1a. Overview map of invasive species around in Black Lake

Overview - During the first inventory in June, the only invasive species discovered was a small patch of invasive phragmites along the north shore of the lake. Considering the small presence of invasives during the first inventory, the second inventory was planned for approximately a month later to allow time for further growth of all species. During the second visit in August, there were numerous sightings of purple loosestrife, reed canarygrass, invasive mute swans and native phragmites. The locations of all these species can be found on the Black Lake map (Figure 1a).

Overall, there was a total of 25 different sites that contained invasive species. The majority of these sites consisted of purple loosestrife, with only a few being either invasive phragmites, reed canarygrass or Morrow's honeysuckle. Although there was milfoil noticed in several locations, none of it was confirmed to be Eurasian watermilfoil, the invasive type. During the course of both inventories, approximately 35 linear miles were covered.

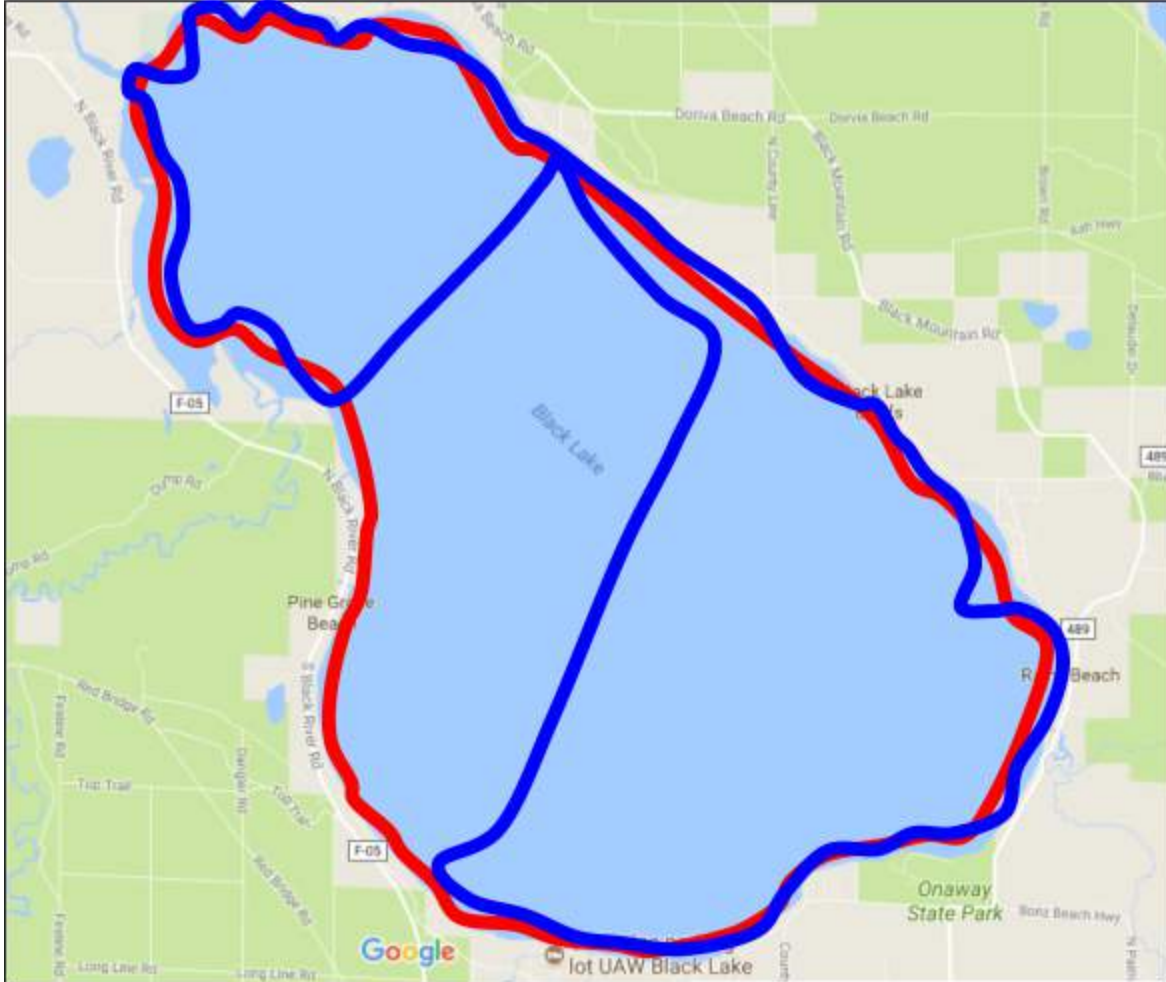
Figure 2. Map showing the route navigated during the two separate inventories. The red line represents the first inventory on June 21 and the blue line represents the second inventory on August 24.

The first inventory occurred on June 21 and consisted of a full inspection of the perimeter of the lake, both in the water and nearby shoreline. This inventory was completed by boat, wading where necessary to allow for closer inspection. The second inventory occurred on August 24 and utilized a transect pattern, with emphasis of the more shallow waters where submerged aquatic plants could grow. The second inventory was also completed by boat, wading where necessary to allow for closer inspection. See Figure 2.

During the second survey in August that consisted of the lake transect, the nearshore environment was re-inspected as well as two long passes across the lake where the water depth was most suitable for aquatic invasive plants (Figure 2). Prior to transect inventory, the Midwest Invasives Species Information Network (MISIN) website was checked to look for any previously identified invasive species sightings. At the time of the survey, no invasive species had been recorded on MISIN for Black Lake. A different boat was also used during the transect inventory for greater efficiency. This was a 16ft flat-bottom Jon boat with a jet propulsion motor. This was used because of its greater stability in the water and ease of the crew to maneuver inside of the boat, especially when getting out for closer inspection.
